## Test Report

NBF25-0010805-01

Sample Name: UVC LED Water Disinfection System

Sample other information: Model Name: MP-UVC-70L

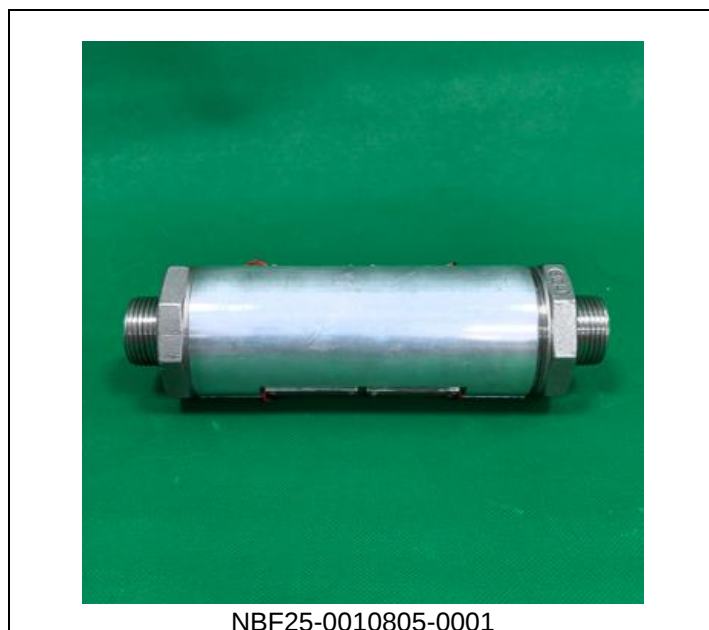
NBF25-0010805-0001

Sample photo:
